APPEAL BY WADDETON PARK LTD

LAND AT HARTNOLLS BUSINESS CENTRE

SUPPLEMENTAL STATEMENT OF COMMON
GROUND - ARCHAEOLOGY

Interim summary results of an archaeological trench
evaluation

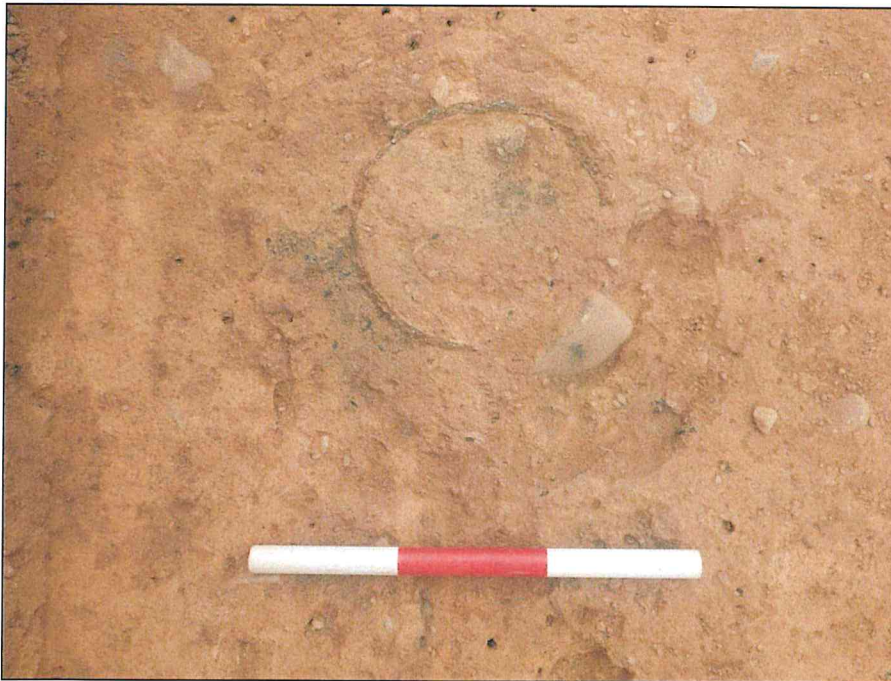
Plate 2: Trench 21, probable Bronze Age cremation pit (2103) containing ceramic vessel, looking northeast (0.3m scale)

This was located against the western boundary of the site and was approximately northeast-southwest aligned. It was positioned in a 'blank' area as interpreted in the results of the geophysical survey. The layer sequence consisted of topsoil (2100) and subsoil (2101) above the natural subsoil (2102), which was present at a depth of 0.38m below ground surface. The trench contained two probable pits - (2103) and (2104) - both of which were unexcavated. Two fragments of prehistoric pottery were recovered from the surface of pit 2103, while what appeared to be a complete pottery vessel was left *in situ*. The exposed fill of pit 2104 was noted as being charcoal-rich.

A pair of unexcavated adjacent probable pits – (2103) and (2104) – were present in Trench 21. One of them, (2103), contained a buried ceramic vessel of probable Bronze Age date. Buried vessels of this type typically contain cremated human remains and is a burial rite characteristic of the Bronze Age. These are often associated with barrows, or ring ditches assumed to have formerly been associated with a barrow, but may also be found in a simple flat cemetery without obvious evidence for above ground markers. The charcoal-rich fill of neighbouring pit (2104) is suggestive of this also potentially containing cremated and pyre remains. Excavations on the land to the west of the current site revealed an almost complete pottery vessel of probable Middle Bronze Age date which contained a deposit from which quantities of charcoal and burnt bone were recovered (Sheldon and Whelan 2015).

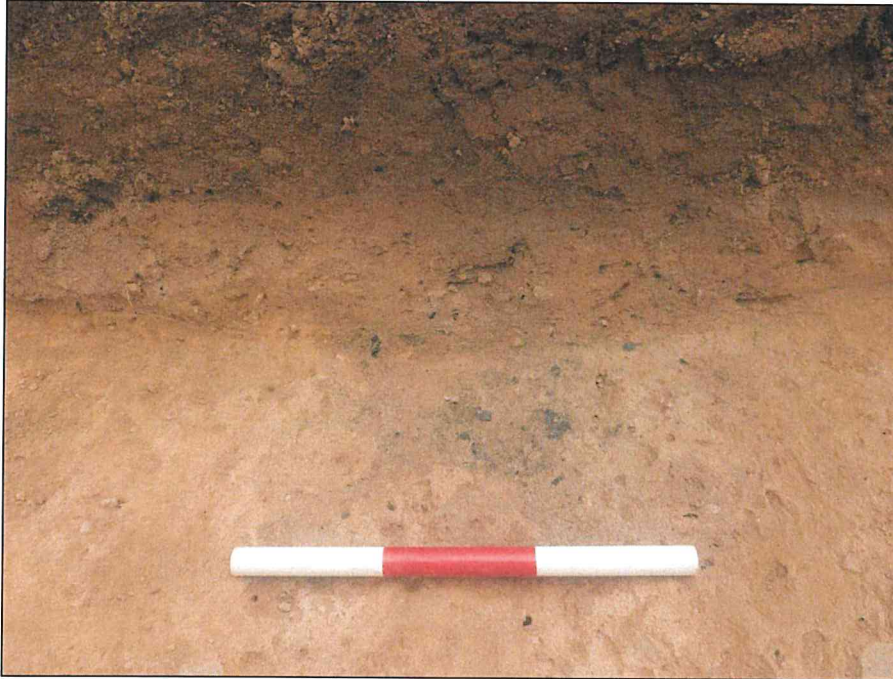
Plate 3: Trench 21, possible Bronze Age cremation pit (2104), looking southeast (scale 0.3m)

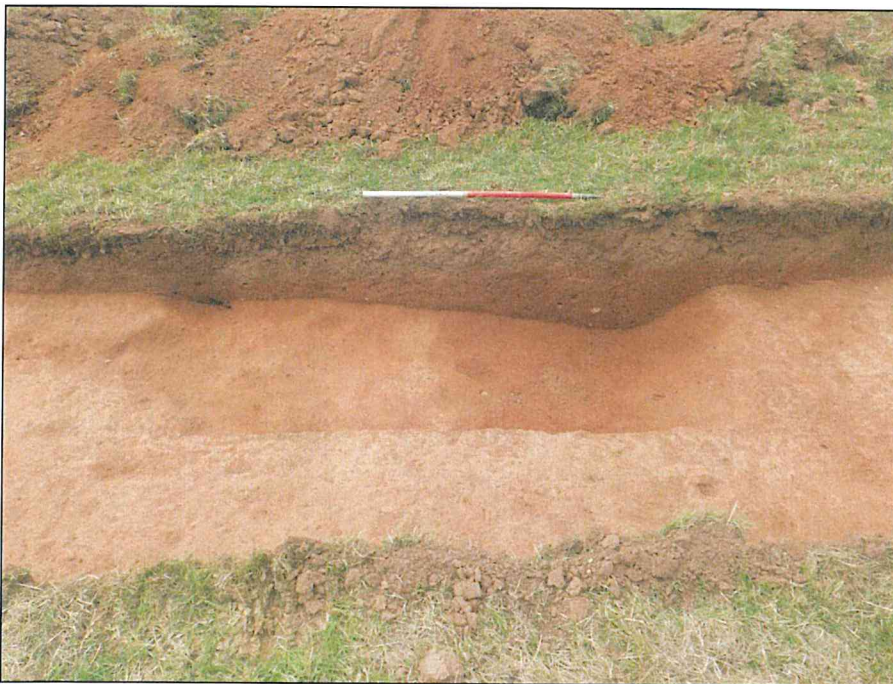
Plate 4: Trench 27, post-medieval ditch F2703, looking northwest (scale 1m)

This was located in the southeast corner of the site and was approximately north-south aligned. It was positioned in the location of one linear anomaly as interpreted in the results of the geophysical survey. The layer sequence consisted of topsoil (2700) and subsoil (2701) above the natural subsoil (2702), which was present at a depth of 0.42m below ground surface. The trench contained a pair of parallel ditches (F2703 and F2705) on either side of associated bank remnant (2707). The ditches and bank corresponded with the geophysical survey anomaly. A single piece of prehistoric worked flint and one sherd of post-medieval pottery were recovered from ditch F2703. F2705 contained a single sherd of medieval and four sherds of post-medieval pottery.

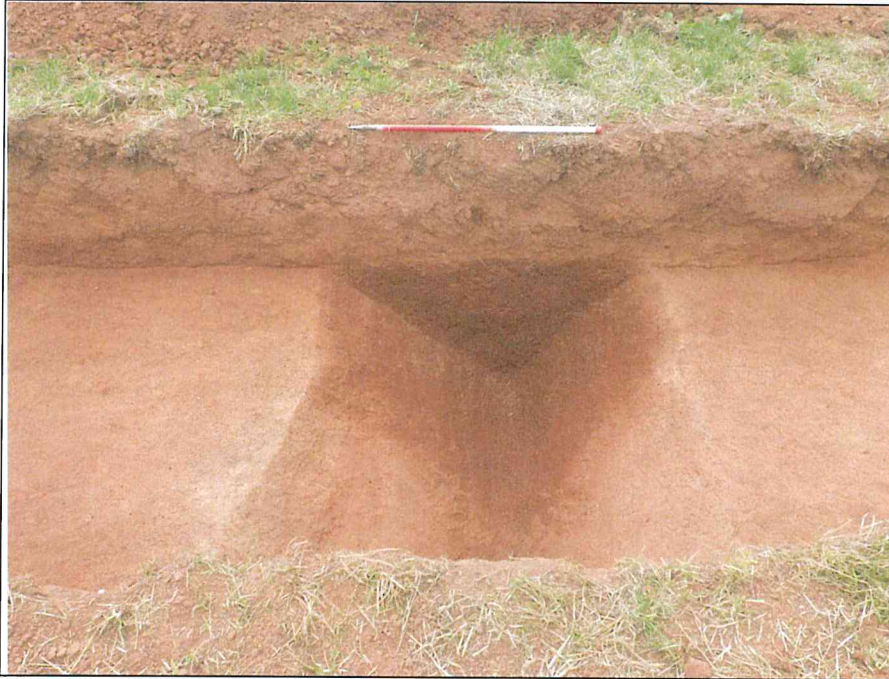
Plate 5: Trench 30, possible prehistoric ditch F3003, looking southeast (scale 1m)

This was located in the southeast corner of the site and was northeast-southwest aligned. It was positioned in the location of one linear anomaly as interpreted in the results of the geophysical survey. The layer sequence consisted of topsoil (3000) and subsoil (3001) above the natural subsoil (3002), which was present at a depth of 0.58m below ground surface. The trench contained a single ditch (F3003) which contained nine pieces of prehistoric worked flint and corresponded to the geophysical survey anomaly.

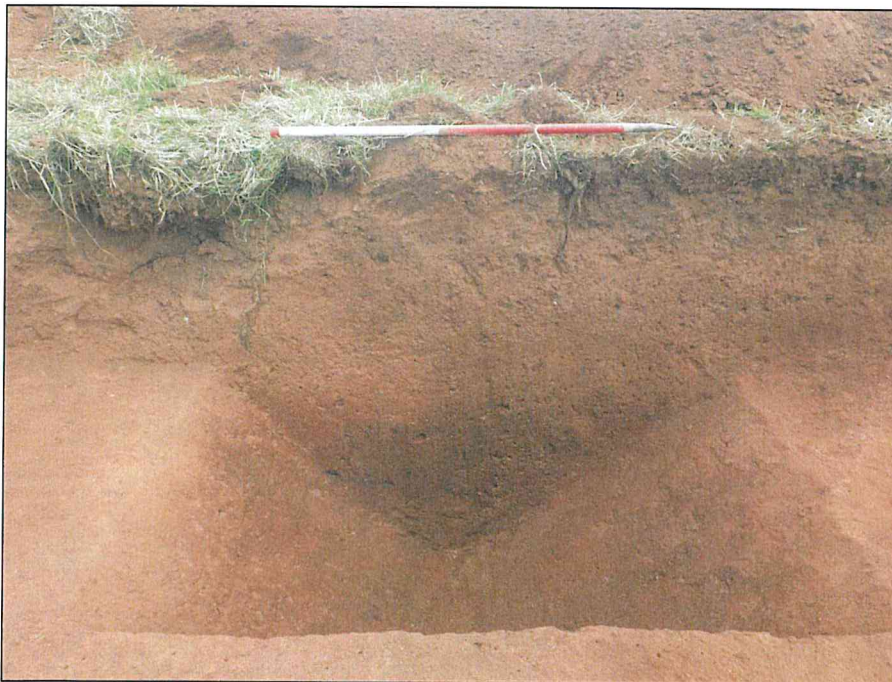
Plate 6: Trench 32, ring ditch segment F3203, looking northeast (scale 1m)

This was located in the southeast corner of the site and was northwest-southeast aligned. It was positioned in the location of a ring ditch as interpreted in the results of the geophysical survey. The layer sequence consisted of topsoil (3200) and subsoil (3201) above the natural subsoil (3202), which was present at a depth of 0.41m below ground surface. The trench contained two

parts of the ring ditch, one of which was investigated (F3203) and the other unexcavated (3205). The ring ditch corresponded with the geophysical survey anomaly. A modern service trench was also present cutting through the ring ditch. Six pieces of prehistoric worked flint and three sherds of prehistoric pottery were recovered from F3203. A single piece of prehistoric worked flint was also recovered from the surface of 3205.

This was identified as a clear anomaly on the interpreted results of the geophysical survey extending beyond the limits of the site. The ring ditch was exposed in two places within the trench (F3203 and 3205), with the excavated segment (F3203) establishing that it was 1.58m wide by 0.92m deep, with moderately sloping concave sides and rounded base. Three sherds of probable Bronze Age pottery and seven pieces of prehistoric worked flint can be associated with the ring ditch which has an extrapolated estimated diameter of over 20m. Although a substantial example, the ring ditch is characteristic of a former barrow of late Neolithic or Bronze Age date and typically used for funerary purposes. The trench crossed close to the centre of the ring ditch with no internal features such as burial or cremation pits identified. A previous geophysical survey and trench evaluation was undertaken in 2009 (AC archaeology 2009) as part of the Tiverton Eastern Urban Expansion Area and included an area adjacent to the southeast boundary of the site (Fig. 2). A single trench excavated in this area revealed the northeast extent of the same ring ditch, which in this trench was 3.60m wide by 0.4m deep, with the same profile as found in F3203. In the 2009 intervention a prehistoric chert flake, two sherds of late Neolithic pottery and a fragment of bone were recovered from the lower fill of the ring ditch.

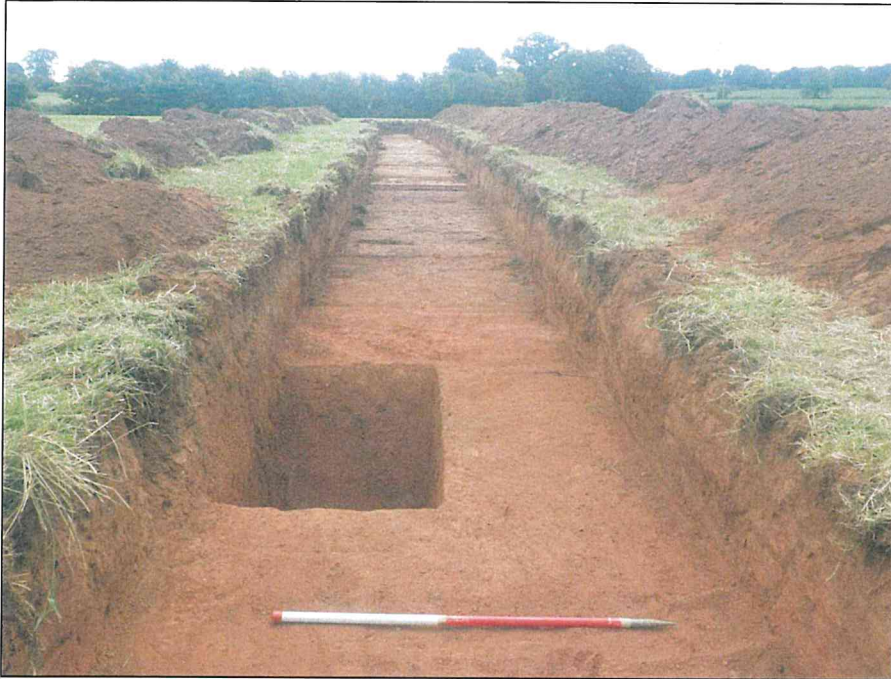
Plate 7: Trench 32, view across ring ditch F3203, looking southeast (scale 1m)
