# Damp & Mould Review 2023

NOVEMBER 2023

Rosie Wills, Technical Support &  
Repairs Manager, MDH

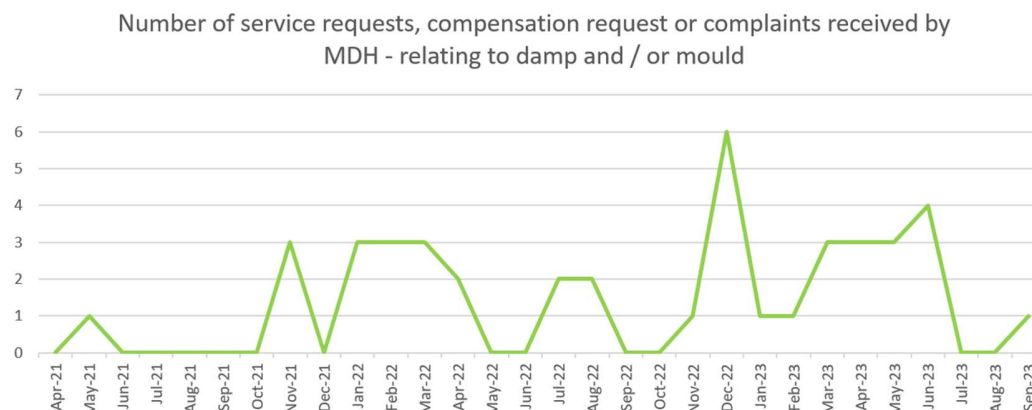
2.21. A breakdown of compensation requests and complaints relating to damp and mould shows that although there has been a slight increase around November 2022, this is not notably different to normal seasonal increases, with January, February and March 2023 seeing less requests than the comparable period in 2022.

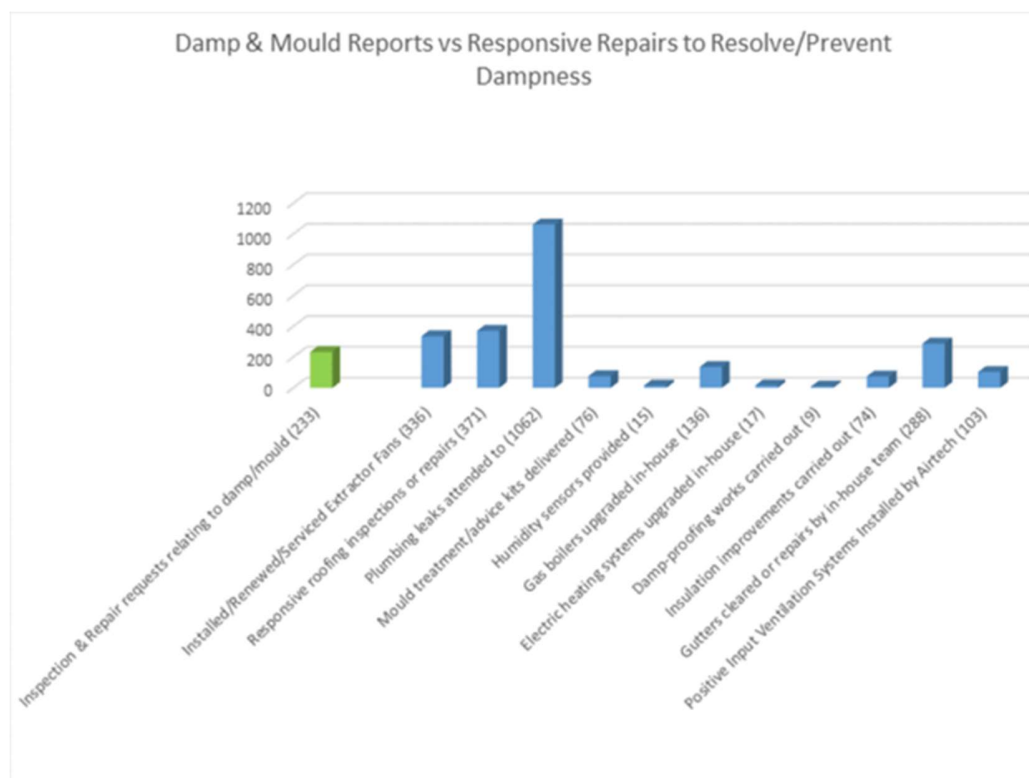
- 4.3. A separate review was carried out, which looked at all repairs and inspections relating to damp, mould and leaks between 1 April 2022 and 25 March 2023 in MDH stock. The total number of reports was 233. Within the same period, a total of 2487 actions, repairs or improvements were carried out to prevent or resolve these issues. This shows that for every one damp, mould and/or leak report, there are nearly 10 actions to resolve, reduce or prevent it. A further breakdown is included in the table below:

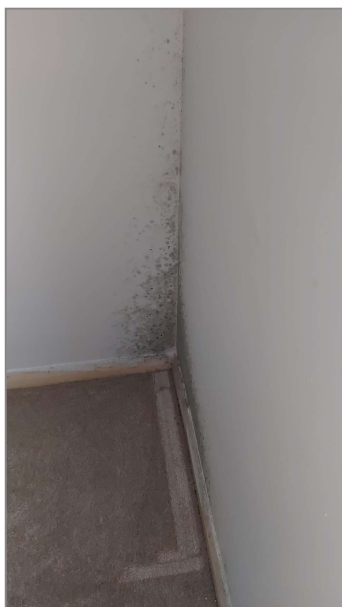
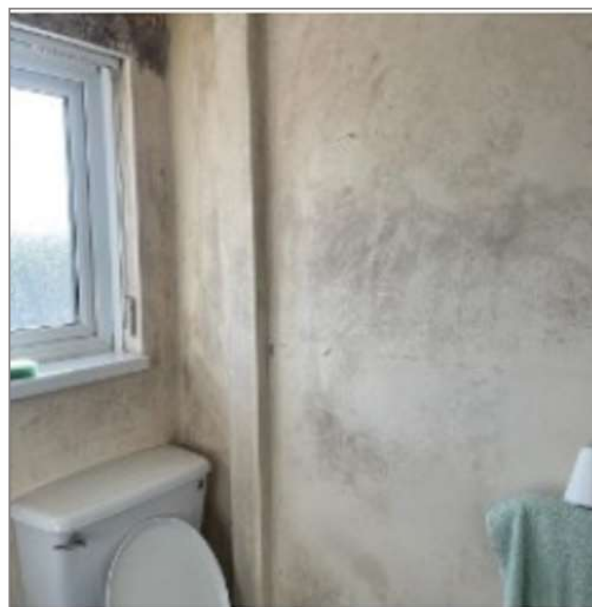
- 9.10. Mould growth will generally form in patterns consistent with thermal bridges, such as those seen in the image on the left. Note the classic crescent shape, as well as the mark on the carpet indicating the presence of furniture close to this wall in a corresponding area. This is what we would expect to see in untreated mould, and in mould previously treated with fungicidal treatment. The photo on the right shows one thermal bridge around the concrete lintel, however the mould is evenly and widely spread over all wall surfaces, including the surface of boxing. There are visible wipe marks. This is indicative of a room which has been ‘treated’ at least once with a bleach solution. Anecdotally, this will bleach the spores, but not kill them, and spreads the spores further around the room during each ‘treatment’. It also seems to feed the mould and worsen the symptoms in general. This is supported by scientific reports.

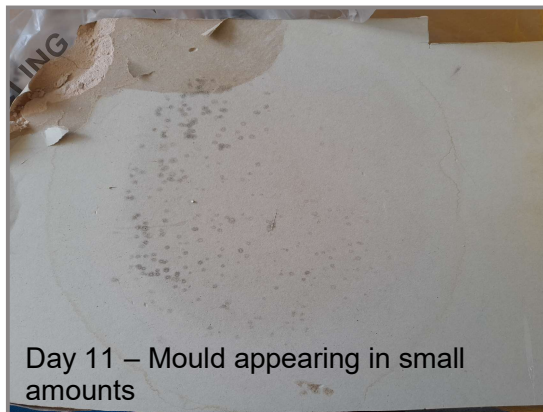
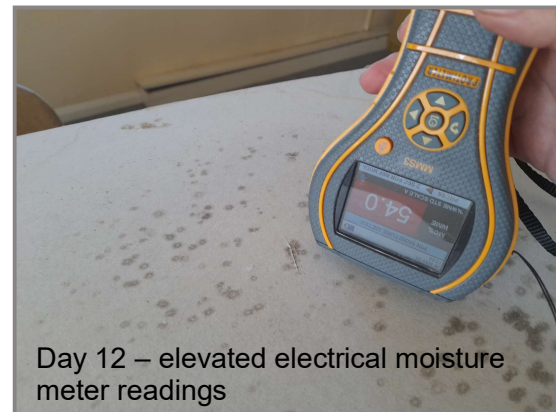
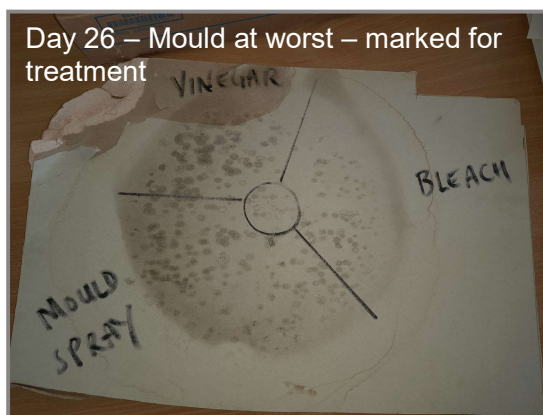
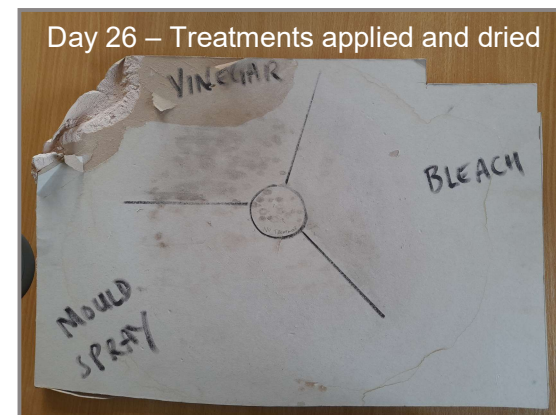
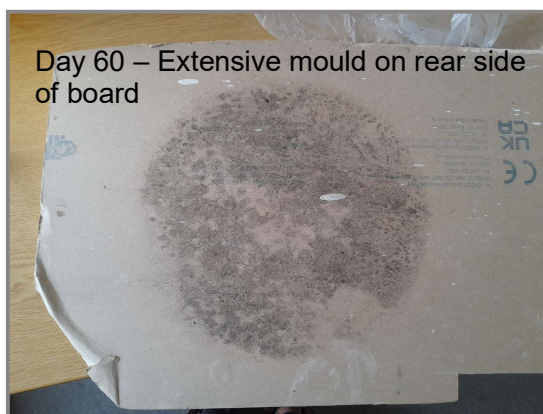
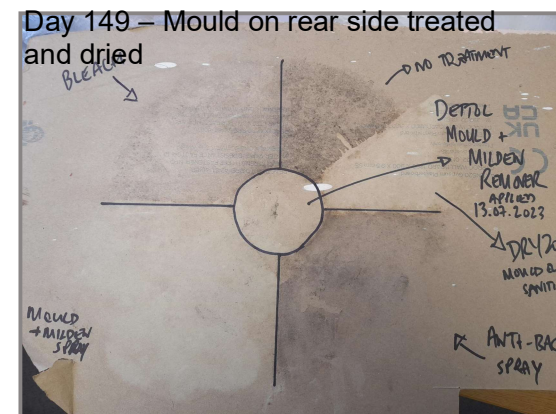
## 9.18. Photos

- 9.17. Sections of the other side of the board were treated with bleach, Dettol mould and mildew spray, a two part Dry-Zone treatment and an anti-bacterial spray.

9.19. A number of factors influenced the experiment, leading to conditions differing to that which we might find in our homes. We will likely repeat the experiment with greater controls to support better learning, and also include Bactdet/Halophen. What the experiment did suggest it is that:

- Widespread and extreme mould can form in the absence of any structural defect or cold bridge if humidity levels are sufficiently high.
- Surface condensation can lead to wetting of a building material, measurable with an electrical moisture meter (more than 60% WME or 999 REL), which in the home environment could be misdiagnosed as rising, traumatic or penetrating dampness.

- 9.11. We carried out a rudimentary experiment in our repairs depot which involved creating an artificial version of the conditions we see in some of our homes, to see what could be learned. A sheet of dry plasterboard was placed in an environment with no direct contact with water, but periods of high humidity. The humidity fluctuated from 50% most of the time, to above 70% RHI for periods of around 2 hours per day. This is consistent with, or less humid than many of the environments we see during regular mould inspections. The temperature of the plasterboard and air remained relatively consistent, at around 21°C. Black spot mould began to form within 12 days.

- 9.12. Despite starting as a dry section of board, measuring 7.5% wood moisture equivalent (WME), by day 12, the first 1-2mm of board had become damp, with readings of 54% WME. By day 18, this had increased to 61%WME. This is despite never having been in direct contact with a water source other than air borne.

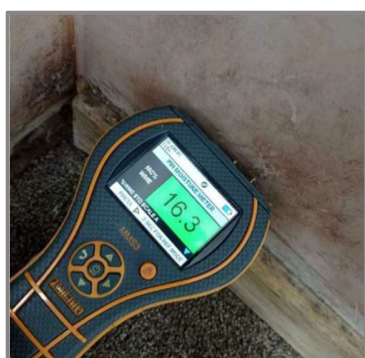
Image 1. Mould growth on the surface of a recently thermal boarded (foil backed) wall, testing as structurally dry. The skirting was also found to be dry, and the cavity sufficiently filled and free of debris. The high internal humidity, which was the primary cause of moisture had not been sufficiently resolved, and so mould persisted. Carpet also has become affected by mildew. A PIV had resolved issues in other rooms, the bedroom door, net curtains and trickle vents kept closed.

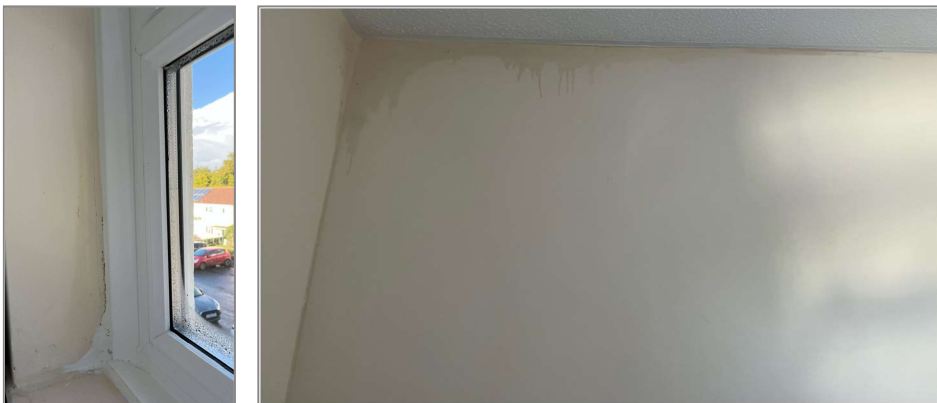
- 11.7. The checks confirmed that there was no roof or window leak, and that the loft was evenly insulated. The combination of the draught proofing of the new windows and the cost-of-living crisis appears to have been the cause of this quite severe presentation of dampness.

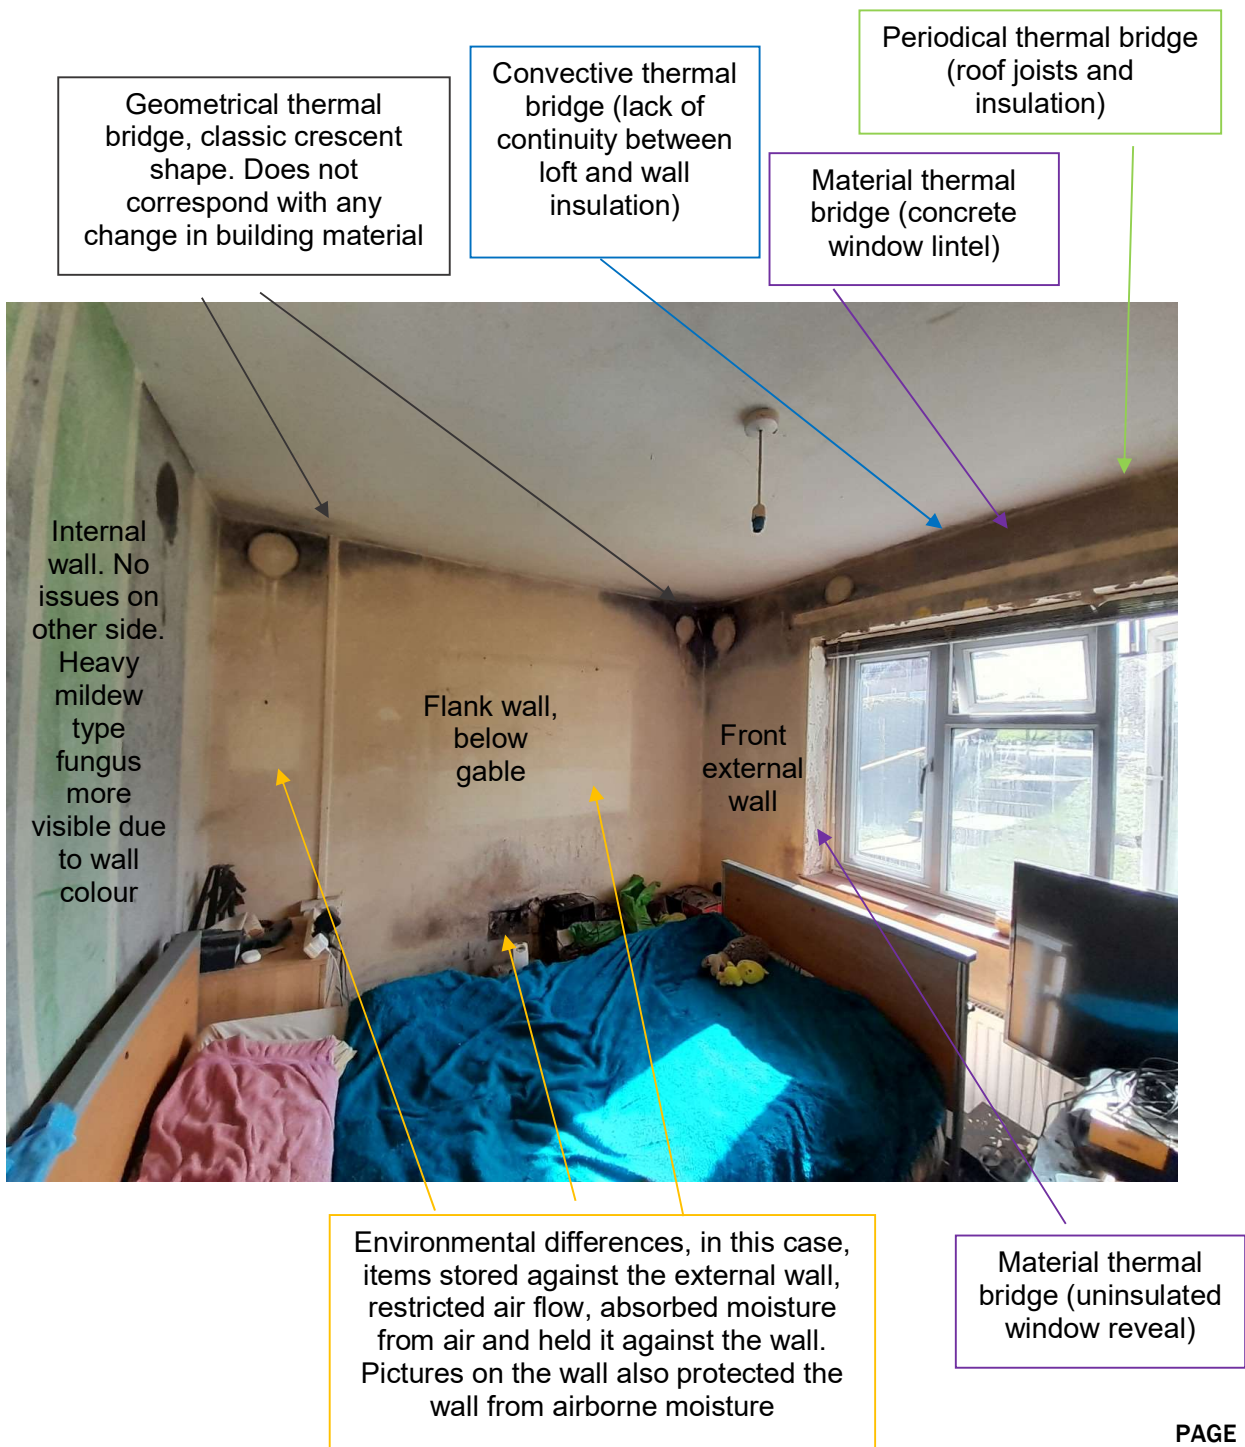
11.14.

11.13. In a fairly extreme example of a property inspected in 2023, a number of these thermal bridges can be seen. Due to the extreme presentation and spread of mould and mildew, on a number of surfaces, it is possible to identify these common bridges.

- 11.15. This example is the same property studied and noted in 15.8 of this report, which further highlights the significance of a lack of ventilation in homes and the benefits of resolving such issues. In this example, it was not the lack of provision of ventilation, but the lack of use. This was heavily impacted by socio-economic issues.

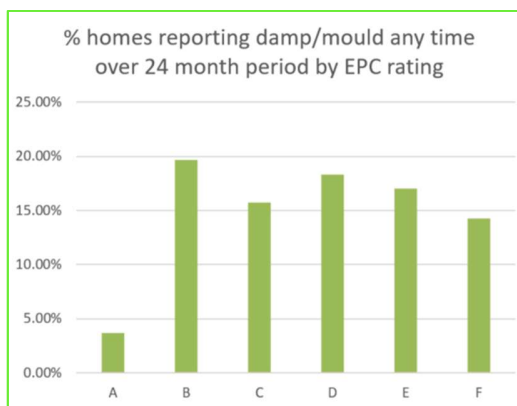
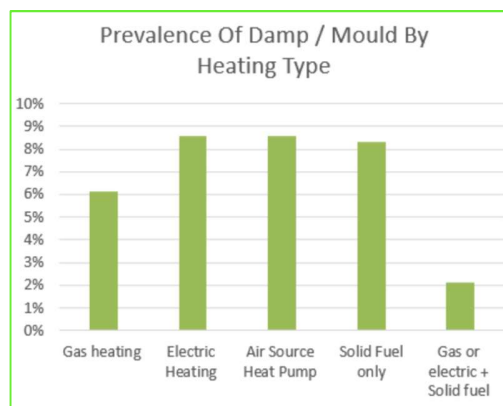
12.18.

12.17. A general comparison of heating type compared with the prevalence of damp and mould in MDH homes is shown below.

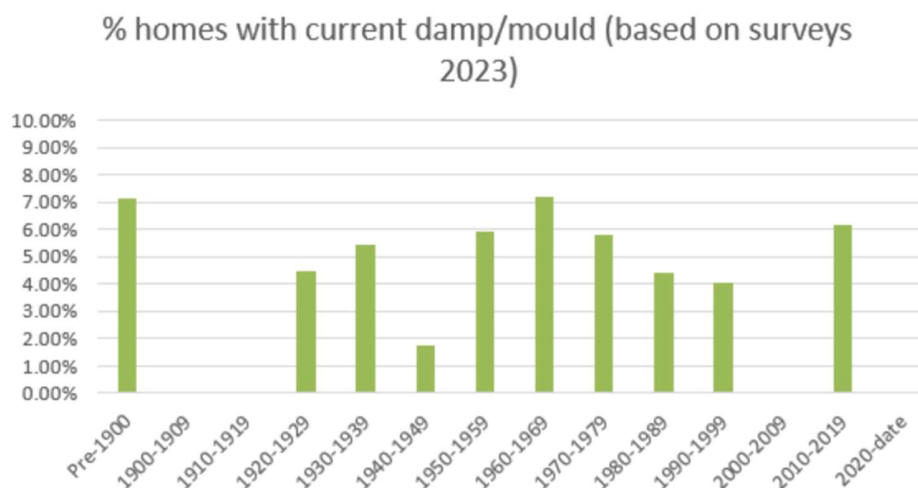
- 12.19. **Construction Era vs Damp/Mould:** The HHSRS rating system recognizes that properties built after 1979 are less at risk of damp and mould, which tied in with key changes in Building Regulations around that time. Our data further suggests particularly low risk construction eras between 1900 and 1919, and again between 1940 and 1949. 1960-1969 is the highest risk construction era, followed by pre-1900 and our newer builds 2010-2019. There is no data for homes 2000-2009 or 2020 to date as no new homes were brought into stock during this period.

- 12.20. The spike between 1960 and 1969 is not surprising, given the number of thermal bridges built into these properties. There are very few pre-1900 properties within the stock, and these have all been fully modernized, with a clash between solid walls, timber single glazing and the expectations of modern living, heating, and ventilation.

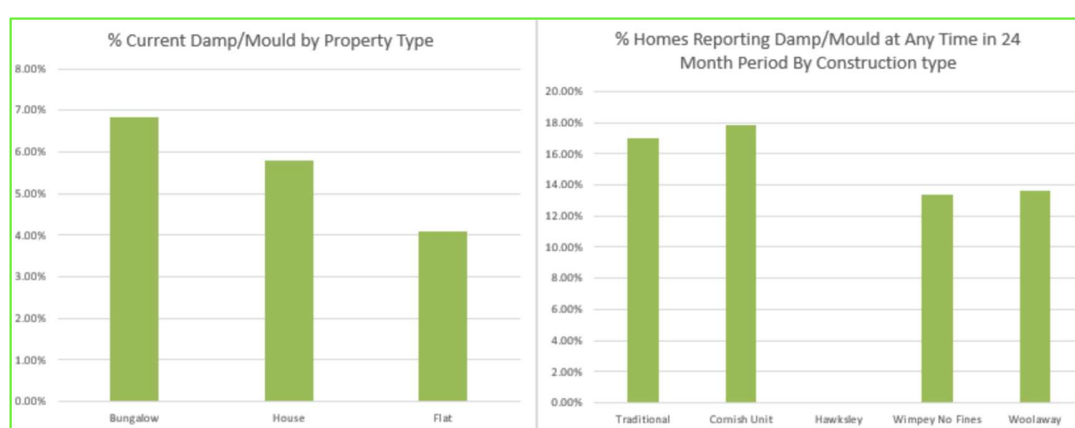
12.23. **Construction type vs damp/mould.** Data relating to property type very much aligned with the feelings on the ground, with bungalows more likely to suffer with damp/mould issues than any other property type. This is likely to relate to the following factors:

- Homes on one level will struggle more with air movement and dissipation of moist air, due to thermodynamics.
- There is a higher total surface area exposed to an external wall, floor or ceiling.
- There is more likely to be a concrete floor slab, than a suspended timber floor.
- The occupants are more likely to be older or disabled.

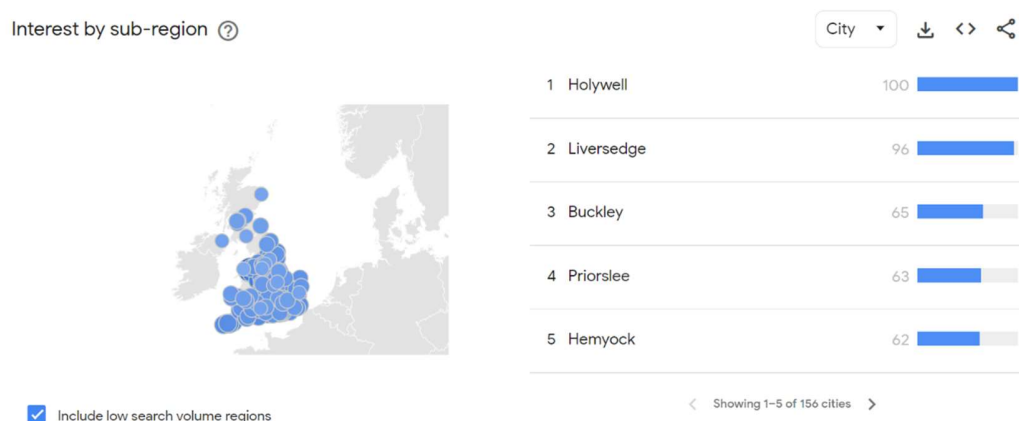
12.27. There are many reasons why the general population of Hemyock and the surrounding areas may be more likely to live in homes affected by damp or mould: It is generally off-gas (95.1%

non-gas properties) and it sits in the Culm River valley (meaning that it is more likely to experience higher levels of humidity). The fuel poverty levels however, are reported to be lower than surrounding areas, at 12.6%. (Non Gas Map, 2023)

- 12.28. In terms of Council owned homes, Hemyock featuring on this list was also not a surprise. There are several flats, for example, with known poor thermal details, which have been difficult to resolve. The flats were designed with built-in asbestos lined bin stores, which protrude into bathrooms. Unfortunately, in most cases, the bin stores do not belong to the bathrooms in which they protrude, so it is not always possible to remove the cold bridge. This has been a longer process of consultation or removing the stores during void periods. In the short term, some internal works, including tile-boarding, heating and ventilation have helped to mitigate the impact.

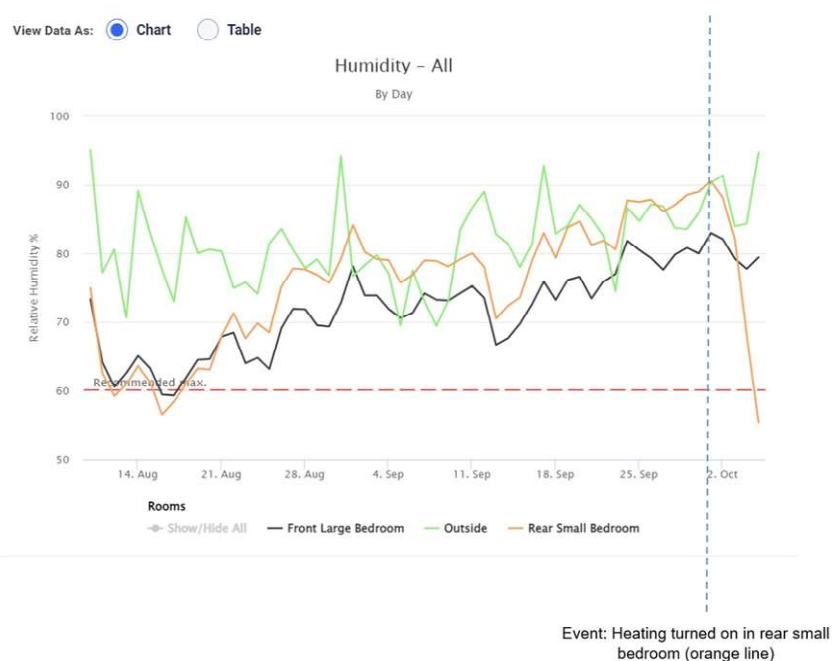
13.5.

- 13.3. During the week commencing 2 October 2023, however, we had breakthroughs with two properties which were being closely monitored.
- 13.4. Property A had been assessed several times and no structural defect had been identified. A PIV had been fitted, but some overcrowding (5 people in a 2-bedroom bungalow) was likely to be significantly impacting on humidity levels and mould affecting furniture and soft furnishings. We were in regular touch with the tenants and had suggested some trial and error, to experiment with balancing heating, moisture production and ventilation. A massive reduction in humidity down to a healthy level was noticed. Communication with the tenant confirmed that this corresponded with heating being turned on in the room.

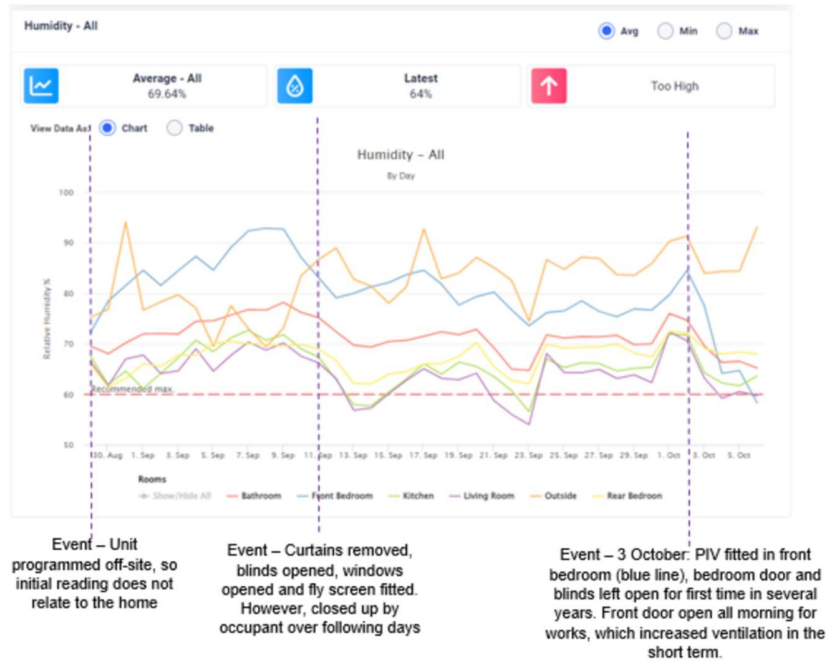
13.8.

- 13.6. In Property B, more significant intervention was required. The humidity and temperature levels were higher than in most properties. CO<sub>2</sub> levels were also being monitored and these were higher than the workplace limit of 5000ppm at over 5500ppm. This was indicative of a severely under-ventilated room. Although the windows were functional, the blinds and curtains were always closed in the front bedroom. The single bedroom was occupied for at least 95% of the day by an occupant with a diagnosis of autism. The main trigger for the damp and mould issues seemed to relate to family bereavement, combined with a childhood phobia of stinging insects. The occupant allowed us to install a fly screen and remove one set of curtains, however, this made little difference.

the affected bedroom, mould treatment and partial clearance of clutter. This led to an almost instant reduction in humidity and room temperature to safe levels. This plateaued after several days but remained less than the 70% associated with new mould growth. The other change reported by the occupants was that the front bedroom door was left open for the first time in several years. Early indications suggest that it is unlikely that the family will receive any social care support because of our referrals on the basis that they will be unable to travel to appointments, or that the support will be refused.

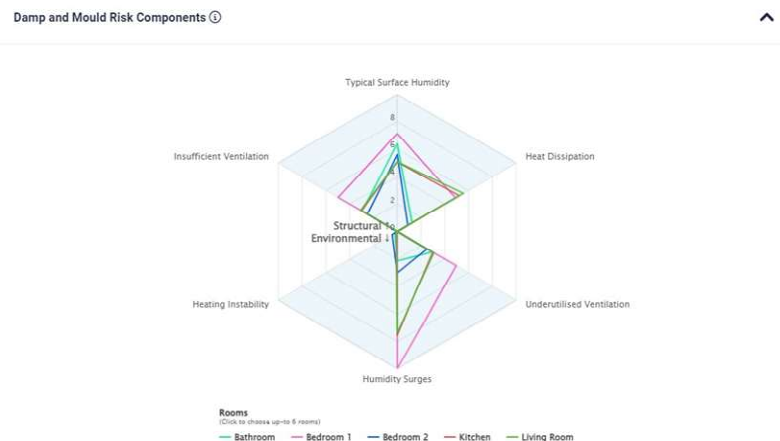
13.9. The monitoring equipment and software (AICO SmartLink) also offers damp and mould insights, which have been beneficial, although this can only be accurately interpreted once it has been in place over a 12-month period, to ensure that a range of outdoor weather is experienced.

13.11. 'Damp and mould risk components' for case study:
